# Seven Construction Issues to Consider for 2015

Draft 12 28  
2014

These are seven issues for large construction sites. I have seen these seven issues quite frequently in 2014.  
- John Newquist

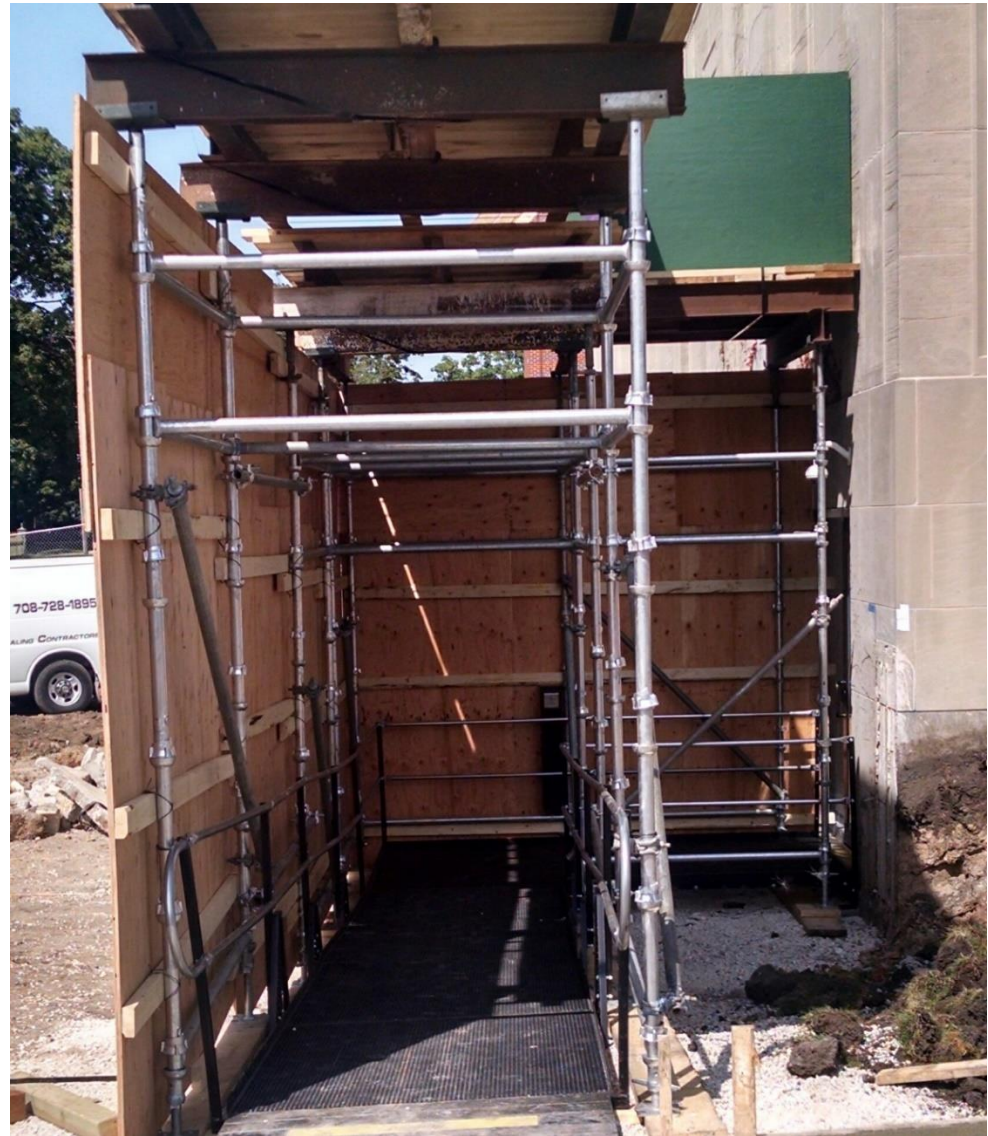
- Manual?
- Jim McGuire  
“Companies tell us to just put it together”
- Tom Hallman “It is the most copied scaffold system there is out there”
- Harsco UK makes the original.

“Should have framed the legs to prevent it from spreading out.”

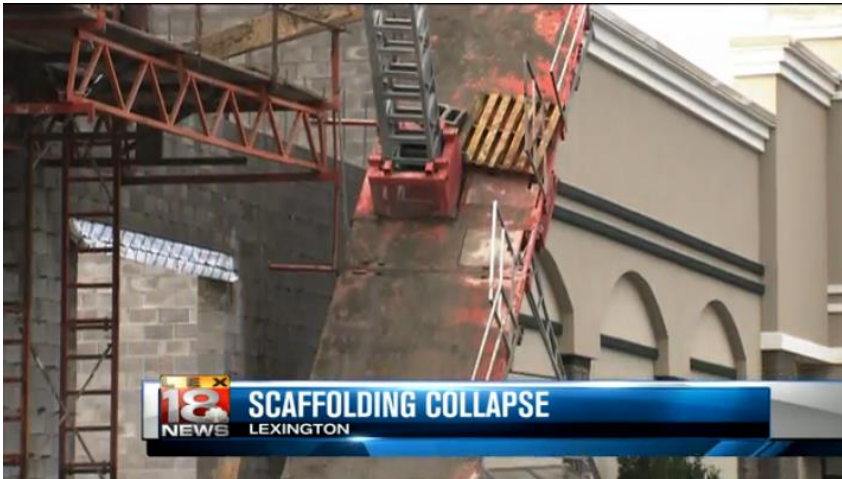
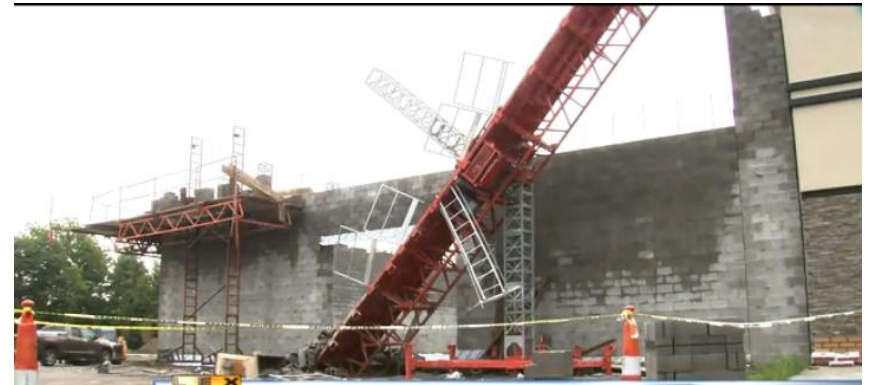
Twin Mast EZ Scaffold, TN

# August 2014

Lexington KY  
Three Story fall  
Hardhats save serious injury

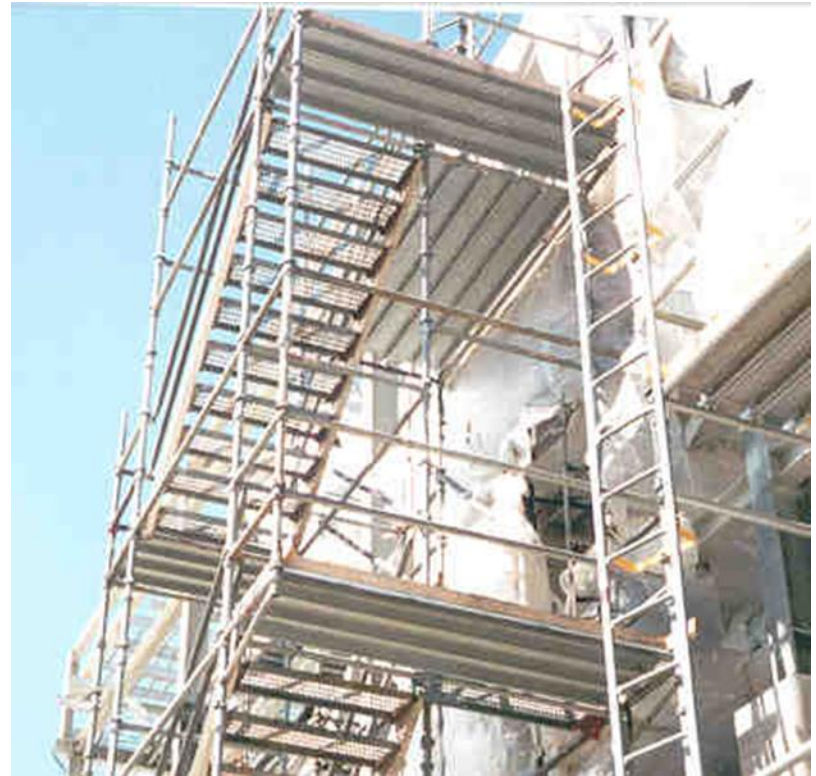
- Access to the roofs are much safer using a scaffold tower with stairs.
- Ladders are the #1 cause of fall deaths in construction.

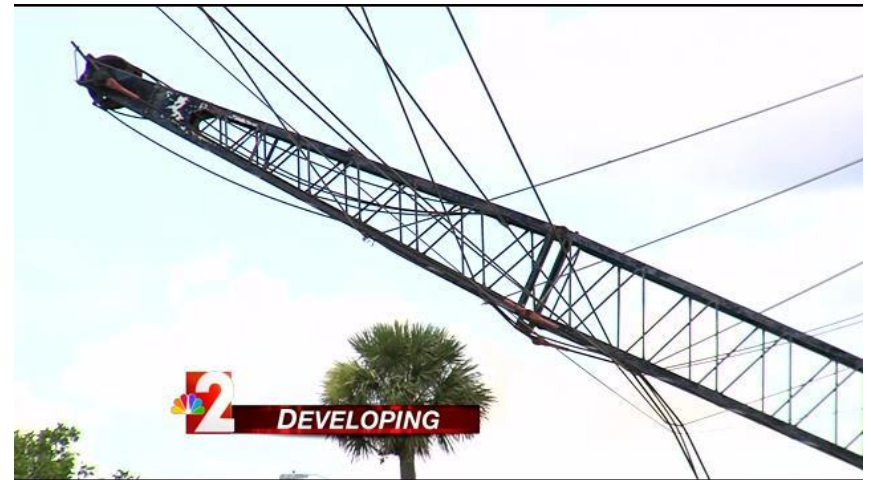
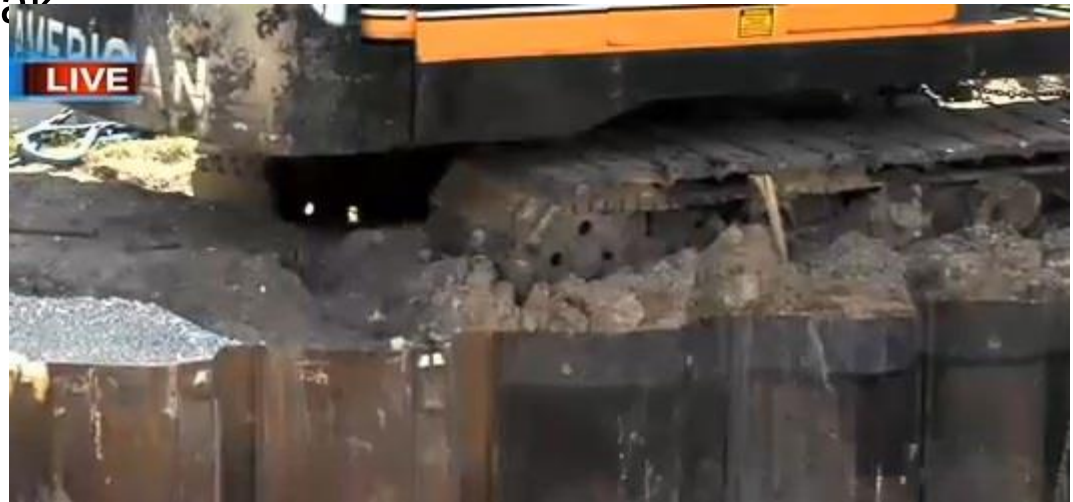
- July 2014
- More than 300 customers in Port Charlotte FL, lost power around 1:15 pm Thursday after the crane collapsed onto power lines.
- 100F heat
- Crane sank in mud.
- Lucky the piles did not break

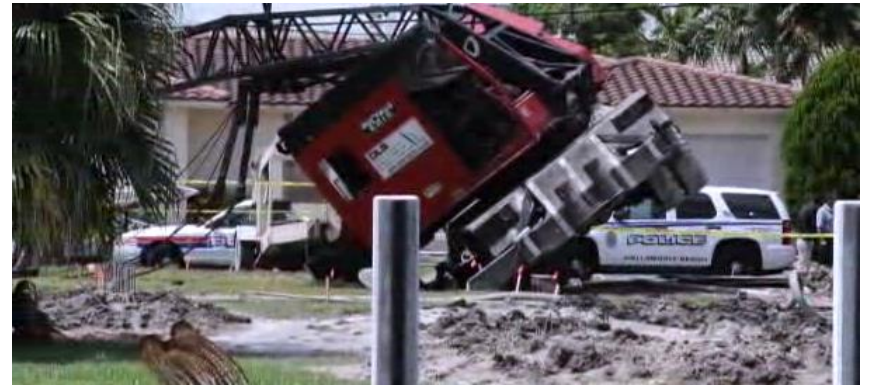
- June 2014
- FL
- Moving crane on unstable dirt
- Boom fell backwards striking construction worker
- No ground matting used, softer soil.

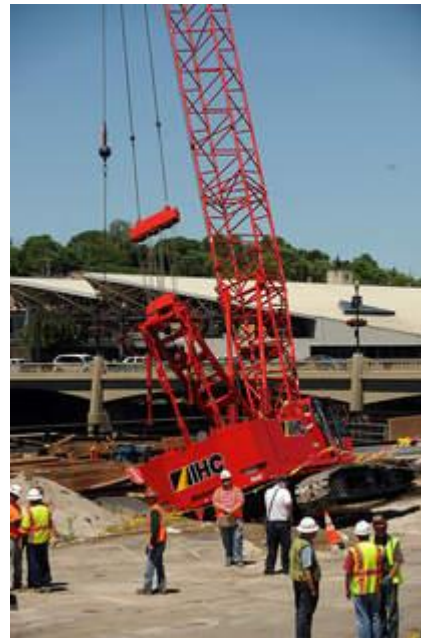
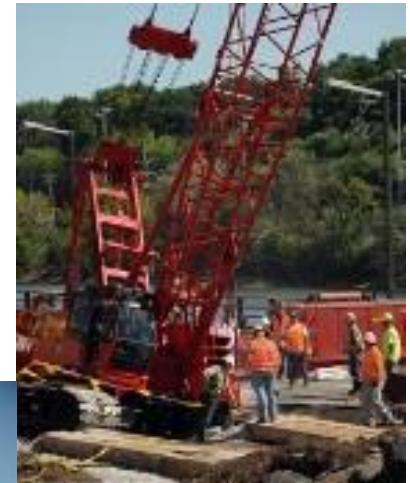
- Firefighters learned that a miscalculation had been made in putting down a track and supports for the crane.
- A difference of about 6 feet too close to the river meant the crane wasn't on solid ground, and it broke through the pavement and leaned slightly toward the river, with its boom over the water.
- Crane too heavy for the surface (precast garage)

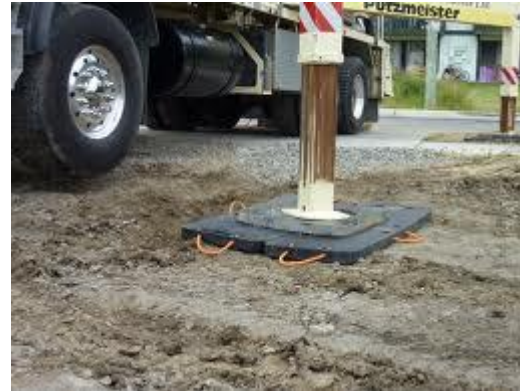
- 1926.1402 (b)
- Ground conditions must be firm, drained, and graded
- Use supporting materials,
- Use equipment manufacturer's specifications for adequate support
- Pad too small

Use equipment manufacturer's specifications for degree of level of the equipment

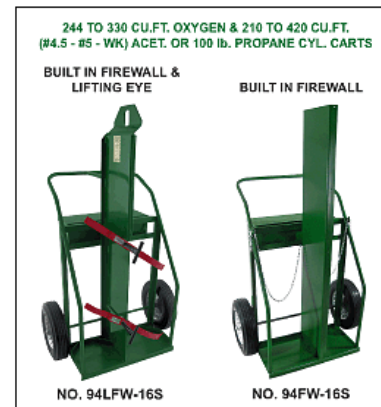
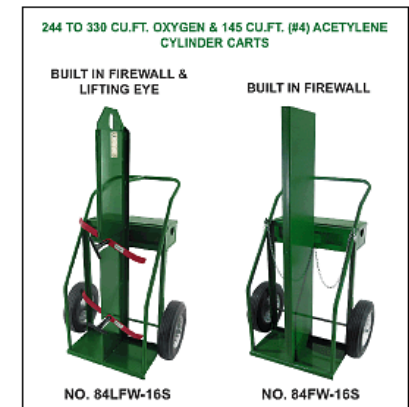
- The literature you provided about these products indicates that the steel barrier has been engineered specifically to meet a **1½-hour fire resistance rating** and to prevent a fire in one cylinder from spreading to the other cylinder on the cart. The barrier is also depicted as meeting the standard's height requirement”

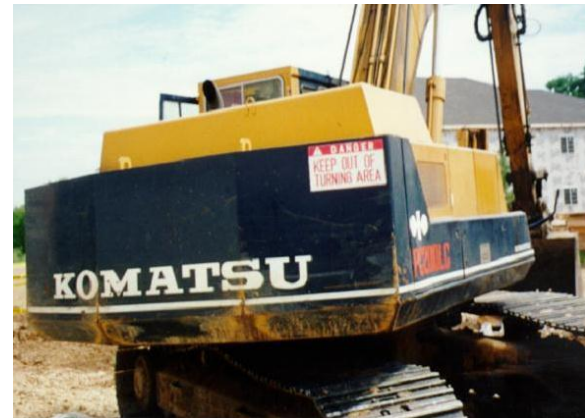
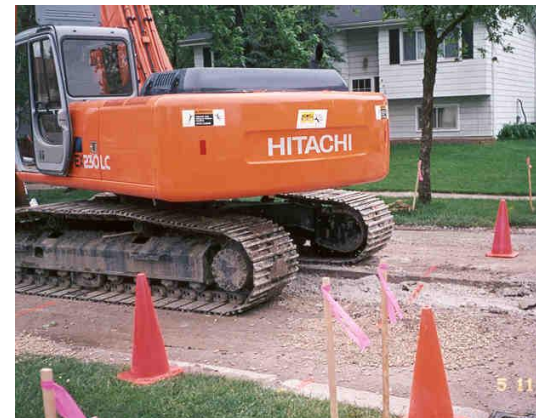
- Violation: Excavator extends 42 inches beyond track. It is able to strike anyone walking by on this site.
- This is incompliance. Cones are used to warn people.

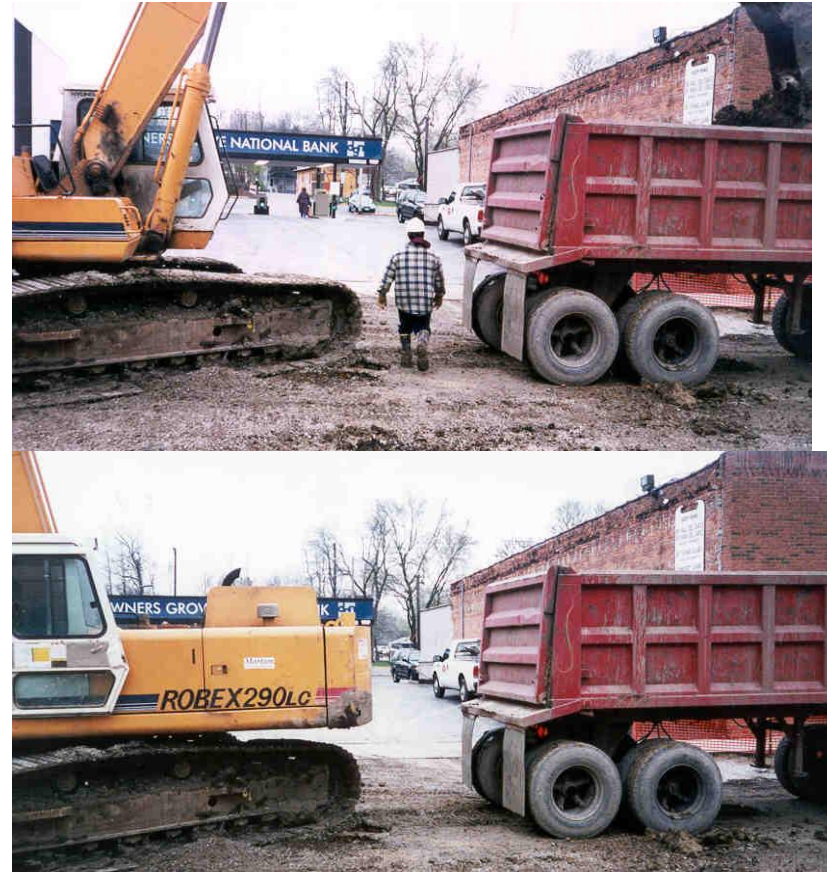
- Area of swing must be marked or barricaded to prevent people in the hazard zone
- Death in 1999 in Rockford
- Cited 5(a)(1)

- 1.Prohibit employees from entering into the swing radius or backhoe pivoting radius during excavating operations. 2.Ensure backhoe operators follow manufactures operations manual and safety precautions.

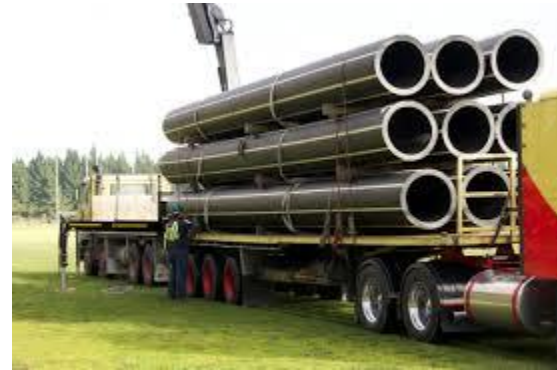
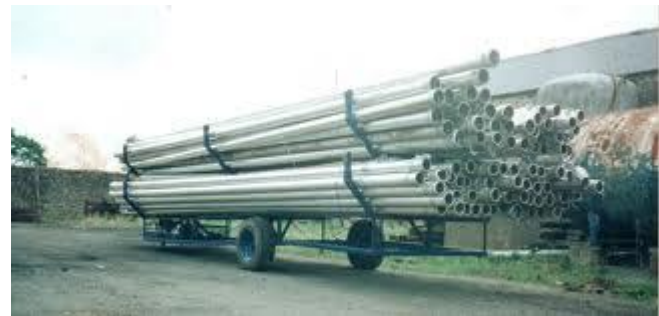
- Mar 2014
- Cedar Rapids IA
- Jacob B. "Jake" Harper, 28, died Friday after steel pipes slipped off of a trailer, struck him and caused fatal injuries

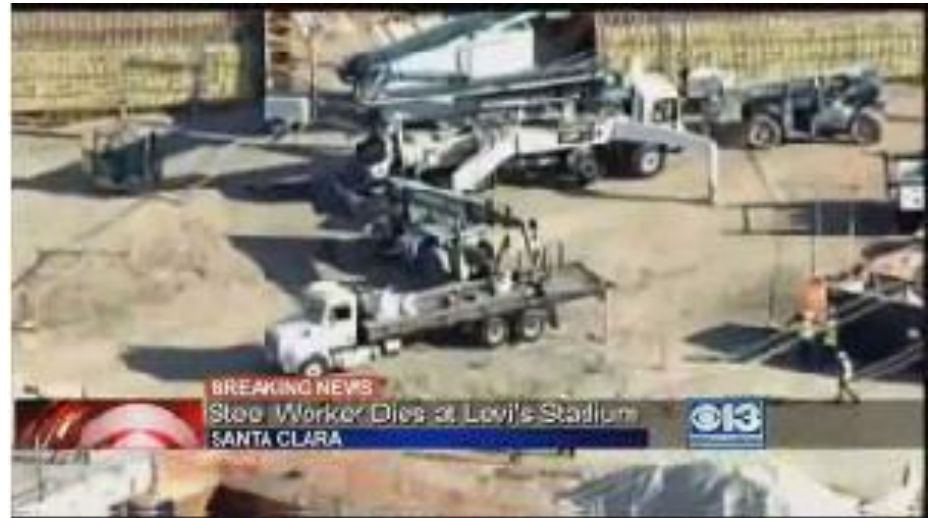
- Oct 2013
- "This employee died when a bundle of rebar he was unloading fell on him"
- The victim, a 61-year-old Vacaville resident was crushed by rebar he was unloading at the **49ers stadium construction site** in Santa Clara, the second worker fatality there in four months, authorities said.

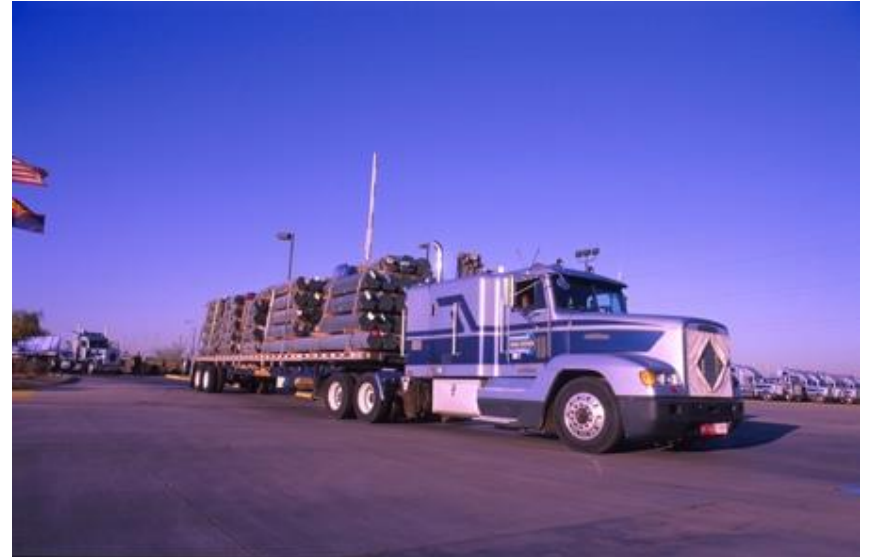
- Two fatalities getting caught between truck and object.
- Trailer often is not level causing load to roll off
- Load straps release improperly stacked loads.

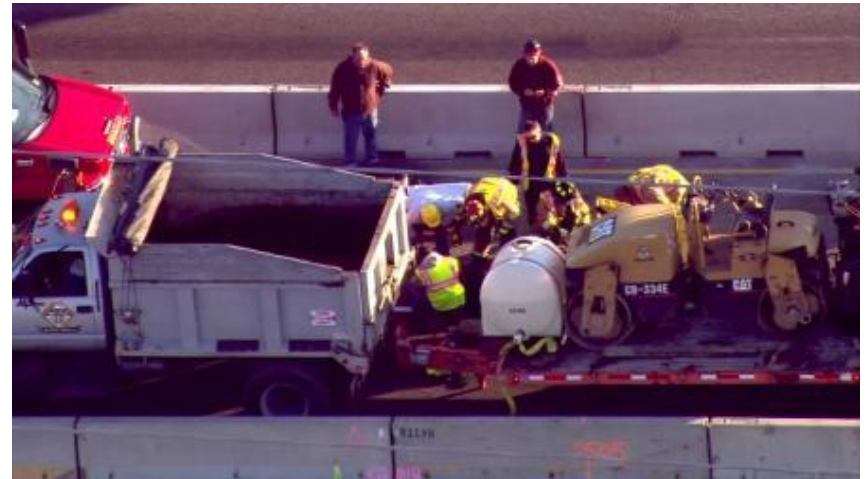
- April 2013
- A worker with a road crew was hurt on the Jane Addams Memorial Tollway Friday morning.
- A piece of paving equipment slid off the side of a flatbed truck, pinning the worker's legs, according to unconfirmed reports.

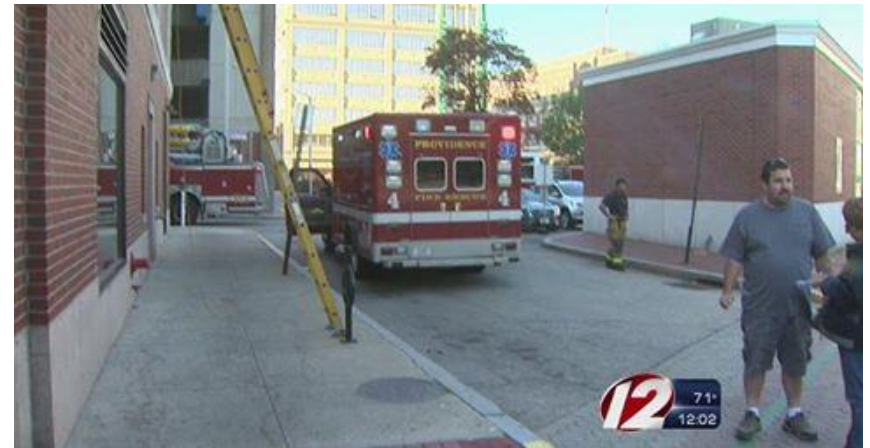
- Sep 2014
- Providence RI
- The worker was taking down an awning at about 9 a.m. when he fell about two stories and landed on his back.

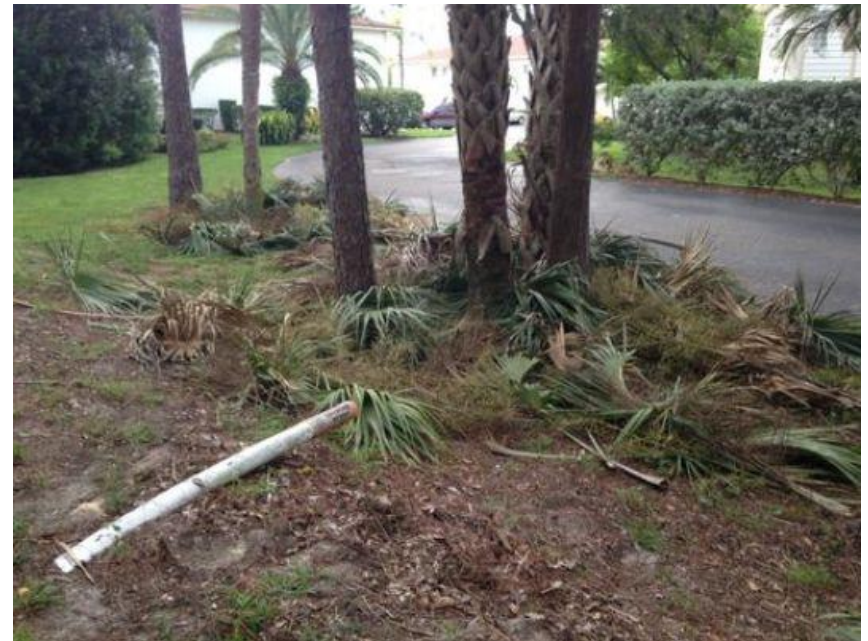
- September 2014
- NAPLES, FL
- Authorities say two men died after being electrocuted while they were trimming palm trees in southwest Florida.
- Batten says the men were working on a 30-foot aluminum ladder that slipped and hit a live power line.
- Consider use of liftpods or aerial lifts
- Consider banning aluminum ladders where any powerlines are on the job.

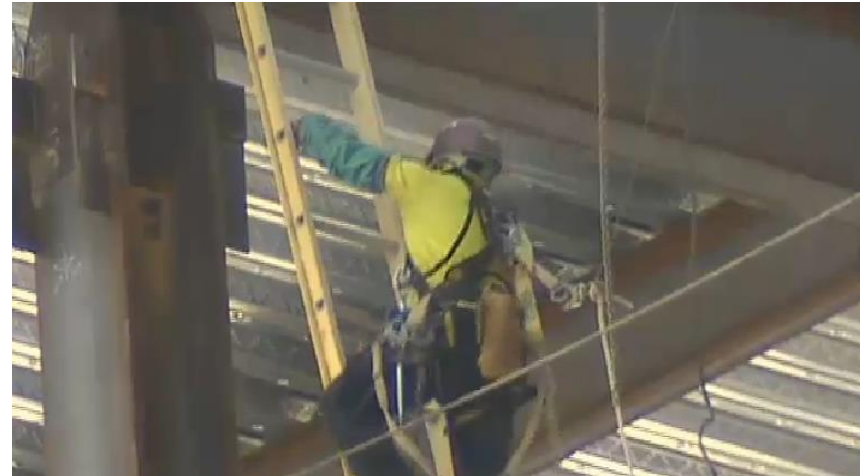
- Consider providing fall arrest to climb to other levels when stairs are not available
- There are 30+ manufacturer rules that must be covered as part of ladder safety training.

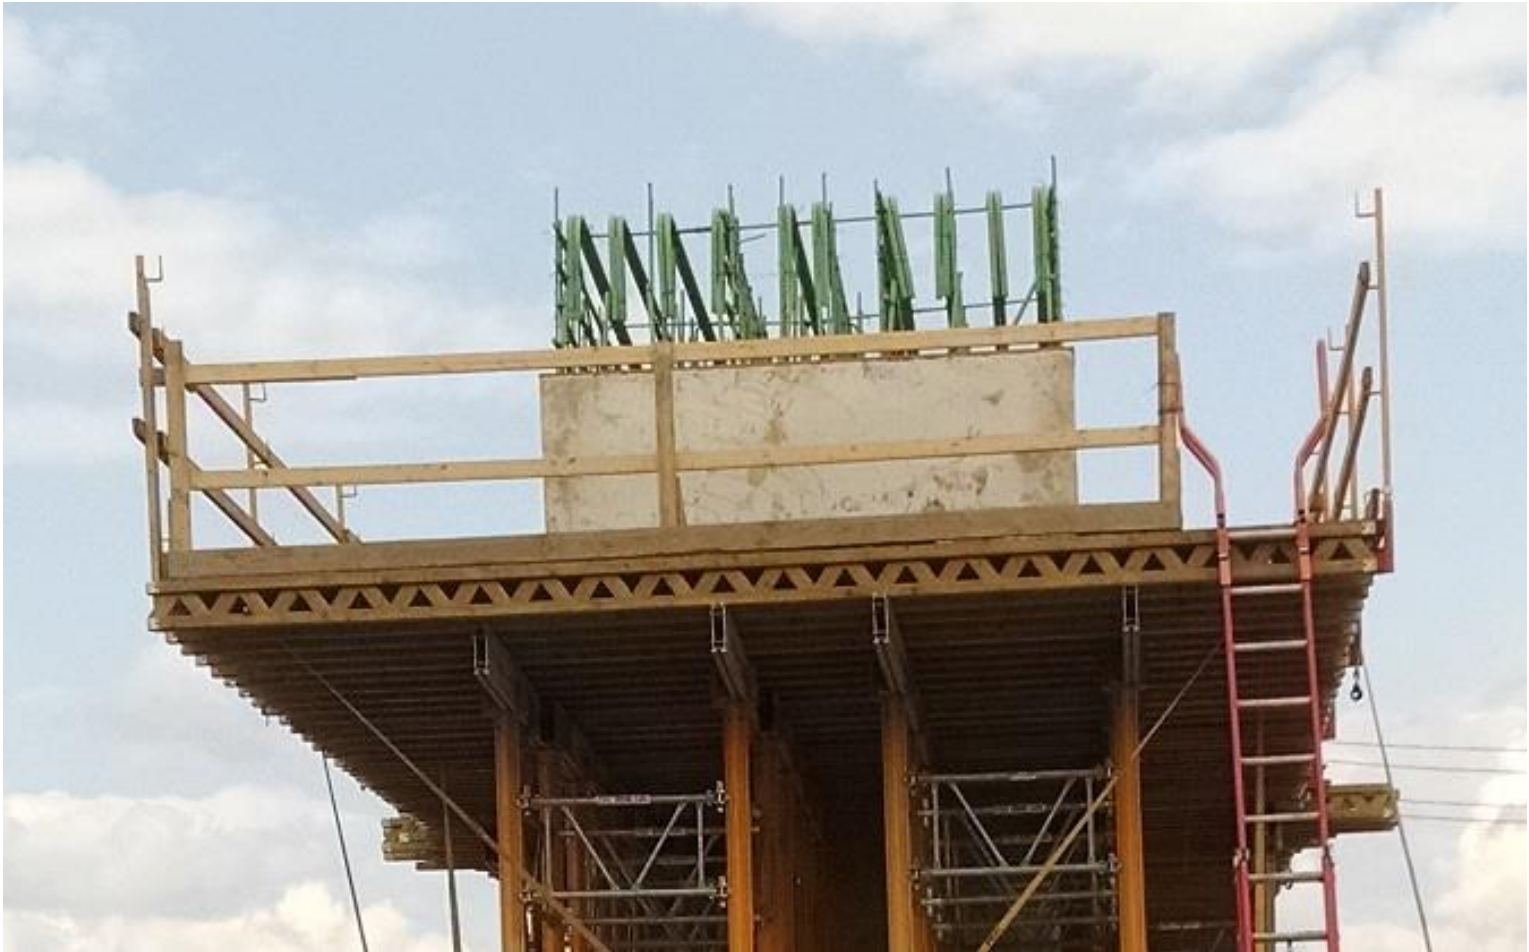
Walkthrough extensions provide safe access to platforms.

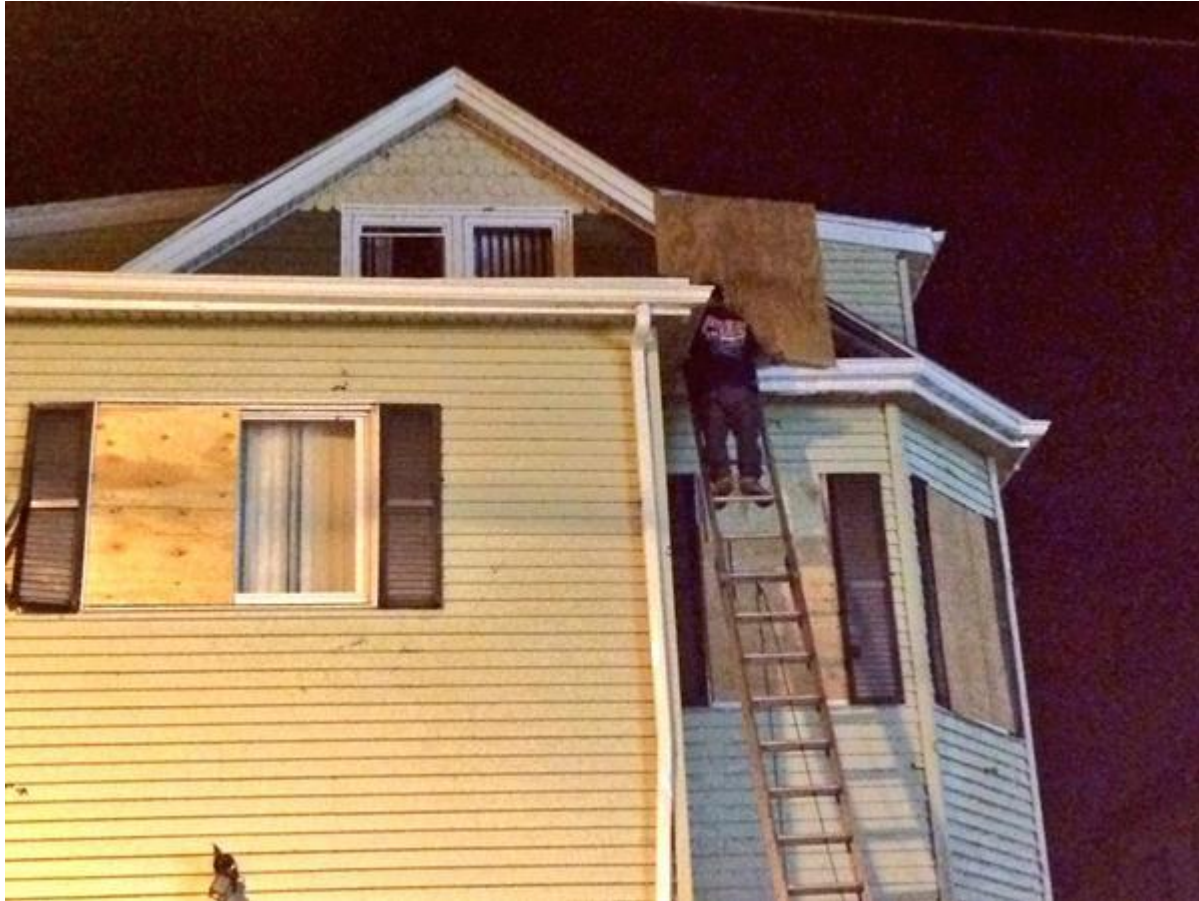
Consider eliminating any work where employees cannot maintain 100% three point contact.
